MARYLAND INVENTORY OF HISTORIC PROPERTIES HISTORIC BRIDGE INVENTORY MARYLAND STATE HIGHWAY ADMINISTRATION MARYLAND HISTORICAL TRUST

NAME AND SHA NO.: M-015 LOCATION Road Name and Number: Glen Road over Piney Branch City/Town: Rockville X vicinity County: Montgomery Ownership: _ State X County _ Municipal _ Other Bridge projects over: _ Road _ Railway X Water _ Land Is bridge located within designated district?: _ yes X no ___ NR listed district _ NR determined eligible district __ locally designated _ other Name of District **BRIDGE TYPE** __ Timber Bridge __ Beam Bridge __ Truss-Covered __ Trestle __ Timber-and-Concrete Stone Arch Bridge __ Metal Truss Bridge __ Moveable Bridge __ Swing __ Bascule Single Leaf __ Bascule Multiple Leaf __ Vertical Lift __ Retractile __ Pontoon __ Metal Girder __ Rolled Girder __ Rolled Girder Concrete Encased Plate Girder Plate Girder Concrete Encased __ Metal Suspension __ Metal Arch __ Metal Cantilever X Concrete _ Concrete Arch _ Concrete Slab X Concrete Beam _ Rigid Frame _ Other Type Name ___

Bridge M-015 carries Glen Road over Piney Branch near Rockville in the southwestern portion of Montgomery County. Rolling wooded hills characterize the

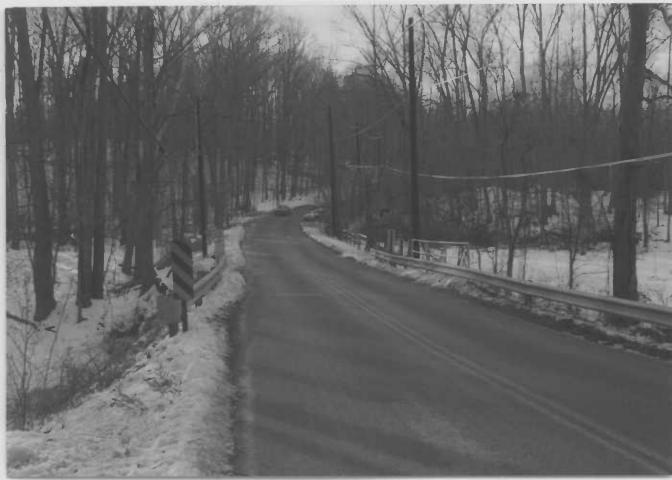
Inventory #<u>M</u>: 25-25

Name MIS-GLENRO OVER PINEY BRANCH
County/State MONTGOMERY MD
Name of Photographer FRANK JULIANO
Date 2 95
Location of Negative SHR
Description WEST APPROACH
Number 33 of 36

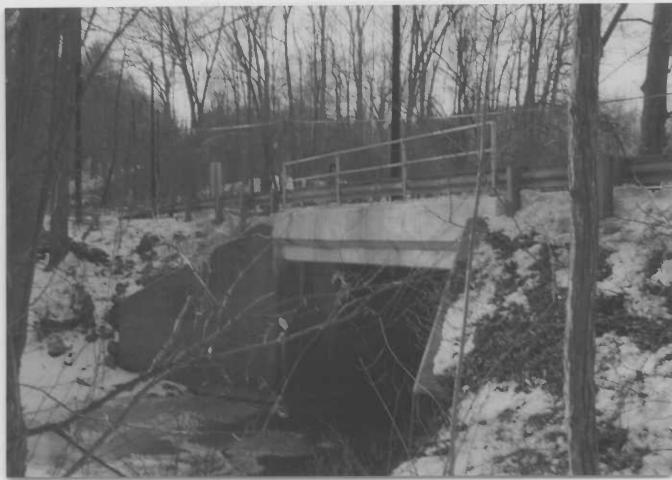
Inventory # <u>M: 25-25</u>

Name MIS- GLENRO OVER PINEY BRANCH
County/State MONTGOMERY MD
Name of Photographer FRANK JULIANO
Date 2 95
Location of Negative SHR
Description ELEVATION LOOKING NORTH

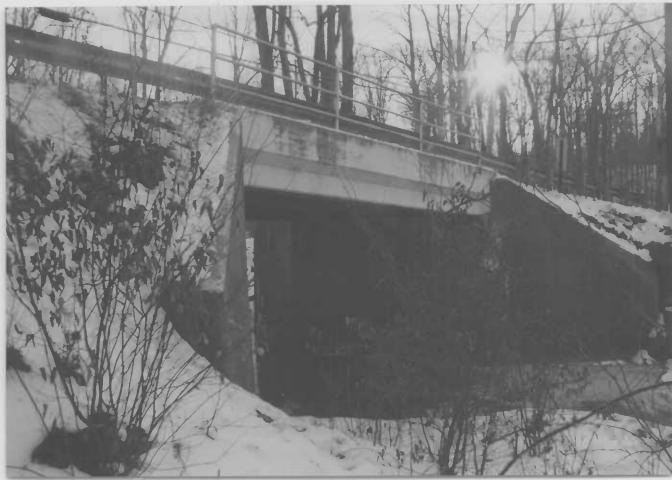
Inventory #M: 25-25

Name MIS-GLENROOVER PINEY BRANCH
County/State MONTGOMERY MD
Name of Photographer FRANK JULIAND
Date 295
•
Location of Negative SHR
Description ELEVATION LOOKING SOUTH
<u> </u>

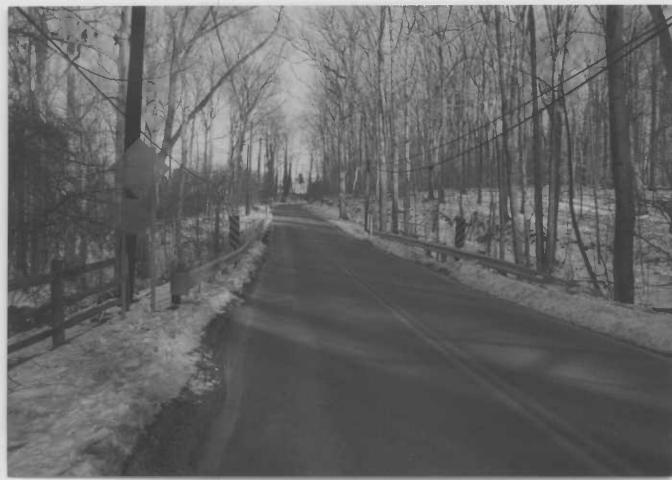
Inventory	#	M:	25-	25

Name MIS-GLEN RD OVER PINEY BRANCH County/State MONTGOMERY MD
Name of Photographer FRANK JULIANO
Date 2 95
Location of Negative SHA
Description EAST APPROACH
•
Number 25 of 35

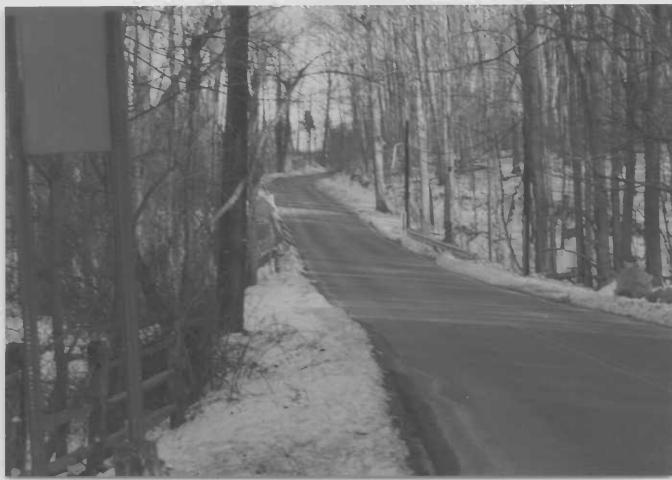
Inventory	#	Mi	25.	25
-----------	---	----	-----	----

Name MIS-GLENRO OVER PINEY BRANCH
County/State MONTGOMERY MO
Name of Photographer FRANK JULIANO
Date 2 95
Location of Negative SHR
Description EAST APPROACH
<u> </u>
